SRL122 (Rev.)

Keeping Up With Research 122

Riparian Forests Protect Streambanks

Wayne A. Geyer

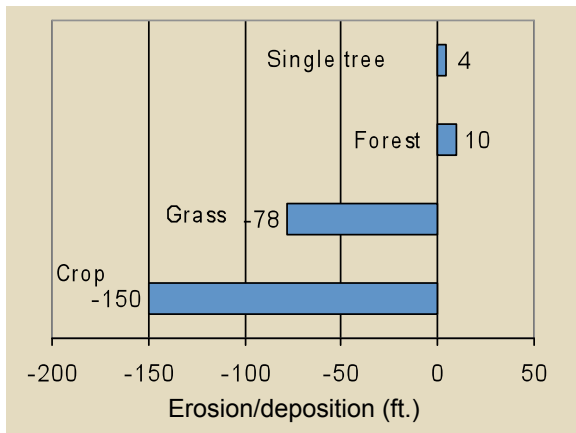
Figure 2. Lateral movement of streambank by land-cover type.

Land-cover vegetation significantly ($P < 0.01$) affected the amount of lateral streambank erosion (Figure 2). Both forest and single tree-row vegetation types collected soil, with mean depositions of 10 and 4 ft, respectively, which were not significantly different. Grassland lost an average of 78 ft, and cropland lost an average of 150 ft. Surface acreage of the lost land was evaluated for each mile of stream erosion: 9.4 acres for grassland and 18.2 acres for cultivated land. The latter is equivalent to about a quarter section of land for every 10 miles of stream distance in this study.

These results show that woody vegetation is highly effective for protecting streambanks. Standing trees slow water movement, thus reducing the energy available for erosion and allowing deposition of suspended materials. Greater rooting depth, larger and stronger roots, and perhaps greater rooting density also stabilize the soil mantle.

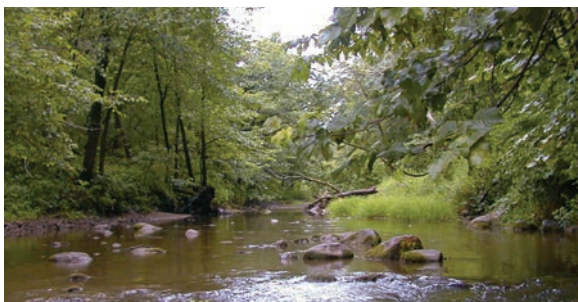
Figure 3. Natural woody vegetation should be left to protect streambanks.
