*An ASAE Meeting Presentation*

*Paper Number: MC04-307*

## **Subsurface Drip Irrigation (SDI) System Remediation - A Case Study**

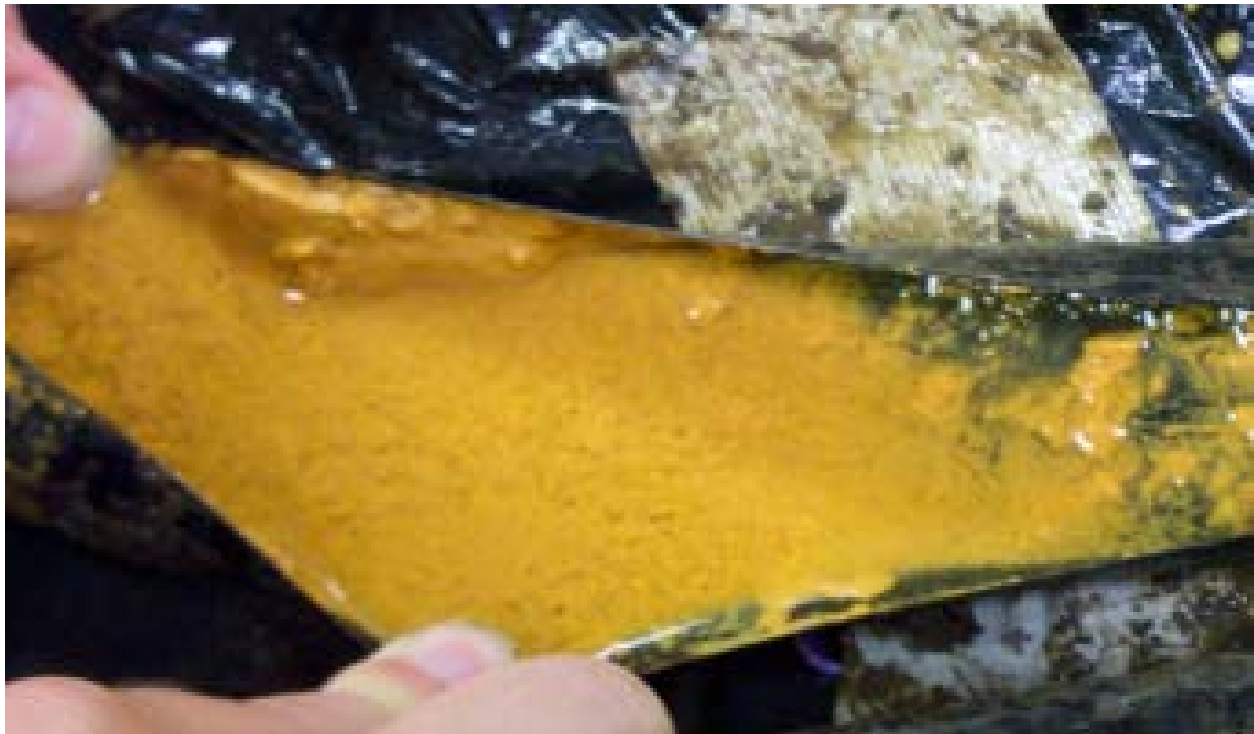
During the winter and early spring of 2002/2003, the producers made contact with K-State Research and Extension personnel. Up until this time, the only operational and maintenance recommendations produced by the designer/installer had been to periodically flush the system. During the initial telephone contacts, verbal generalized information on dripline maintenance procedures, including flushing, chlorination and acidification was provided. SDI bulletins were mailed to the producer. The producer also agreed to have a water quality analysis completed and also removed sample sections of dripline from the visually stressed and non-stressed portions of the field. A cut-away section of the dripline is shown in Figure 2; an orange/yellow paste essentially coated the inner walls of the dripline. The material had slugged off during the handling of the dripline.

Figure 2: Cut-away of case study field dripline showing precipitant accumulation.

An analysis of the precipitant clogging the dripline confirmed it was primarily calcium bicarbonate, colored by the associated iron. The sample length of dripline was tested for flow and found to be almost entirely clogged. The producer indicated he had access to a economically priced sulfuric acid source, however muratic acid was successfully used in the lab test to see if remediation was possible. Sulfuric acid is highly corrosive and may not be the safest and best acid for farmstead use.

A water sample from the well was tested (titrated) to determine effect of a known amount of sulfuric acid on the pH of a known volume of water (Table 2). A 5-foot sample (4 emitters) section of the SDI system had been sent to K-State by the farmer. This sample section was treated by recycling water from a small stock tank of water that had been acidized to a pH level of approximately 2. The tank water was Manhattan tap water, which is of similar chemical composition as the SDI site water, however it was treated with muratic acid.

Water was pumped through the test dripline section for an hour and then shut off for a rest period of 4 hours. This cycle was repeated several times. The four emitters were initially severely clogged with almost no flow from any of the emitters. All emitters recovered to a large degree. However, one emitter recovered quickly and then partially re-clogged and never recovered to the same level as the other three. The results of the cleaning treatment are shown in Table 3. At 9:45, essentially no flow was observed from any of the 4 emitters in the test section. After 1 hour of injection, emitter 3 and emitter 4, to a lesser degree, had recovered some flow. Periodic injection and rest periods continued throughout day 1. The acid treatment was then left in the lines overnight. The next flow measurement showed all four emitters with recovered flow rates of similar values. The treated water continued to be injected during day 2 to observe if any additional flow rate increase would occur. It was during this period that emitter 3 re-clogged. The system was allowed to rest for an additional 4 hours and then retested. Emitter 3 still remained clogged. It was suspected some other particle, rather than the original chemical precipitant had entered the number 3 emitter pathway.

The main recovery in emitter flow appeared to occur during the rest periods. Therefore, during the field remediation trial, acid was injected until the entire system was treated with the low pH water and then left in the system overnight.

The SDI system had been flushed prior to the acid treatment. The system was started and the treatment began. The water was tested using a pH test strip downstream of the injection site and was found to be near the treatment goal of approximately 2 pH.

The flush valves at the ends of the submain were opened to allow any material to be flushed and then closed when the pH reading approached the target level.

A flush valve at the lower end of the system was then opened and tested until the pH dropped. This was repeated at the other outside edge of the SDI system=s flush valve. Injection was continued for another 15 to 20 minutes before shut down. Because the recovery in the test sample seemed to occur due to the long period of contact, rather than due to continuous injection, the SDI system was shut down, saving a great deal of treatment expense.

The injected treatment was left in the system until the next morning. The system was completely flushed the next morning and retreated and left to rest again for approximately 24

hours and flushed again. The field was then irrigated. After three treatments, the system recovered from a flow rate of approximately 480 gpm to 720 gpm.

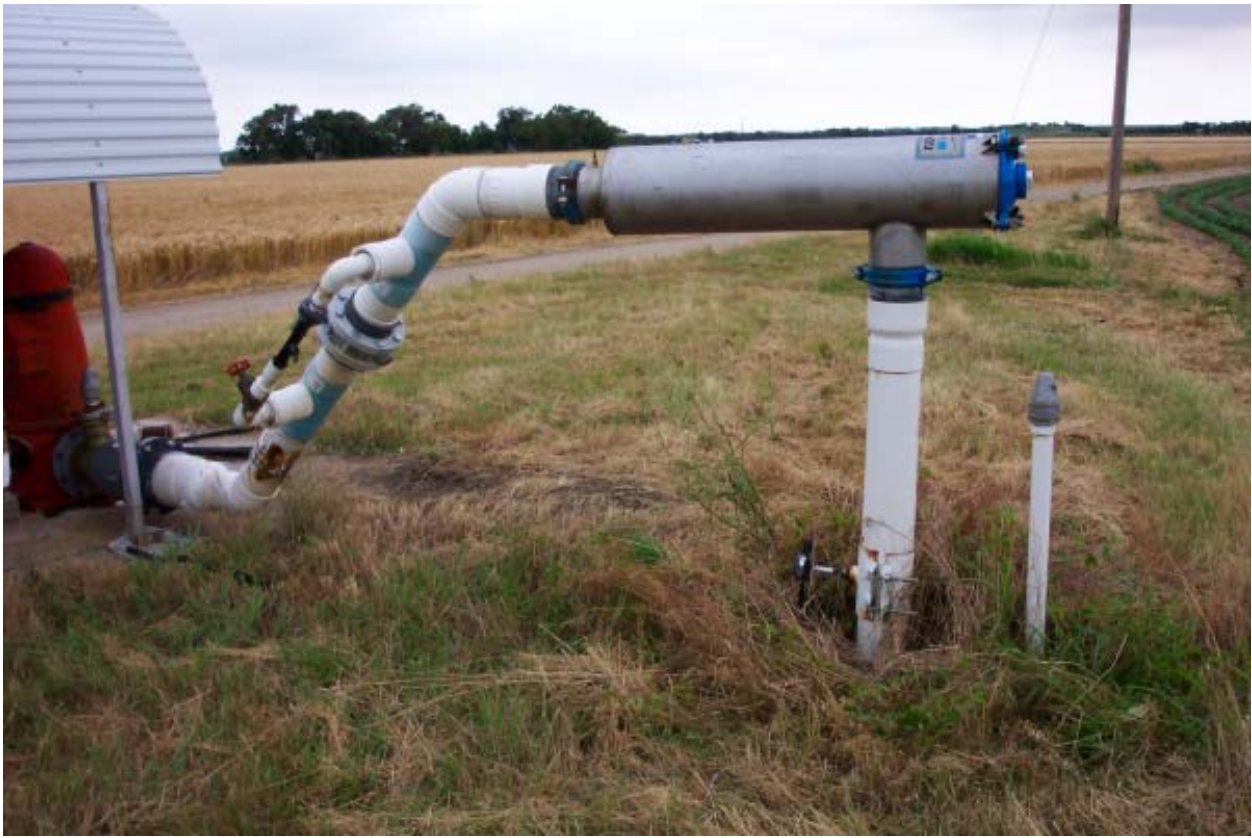
A site inspection was conducted in the early summer of 2003. At this time, the existing soybean crop was also showing water stress in the upper one-third of the field. The system design failed to meet many of the minimum SDI design recommendations that were discussed previously. It was recommended that improvements be made. A new contractor reconstructed the filtration, injection and control valves at the pumping station. The irrigation zone (the field is irrigated as one unit) was also split into two flushing zones. This would allow for higher water flow velocities in the driplines during flushing. Improvements also included addition of air relief vents on the high points of the system, piping and valves to allow direct water bypass from the well, should well treatment be required, and improved placement of the flow meter (Figure 3a and 3b).

Figure 3a: Original pumping plant and filtration configuration of the case study SDI system.

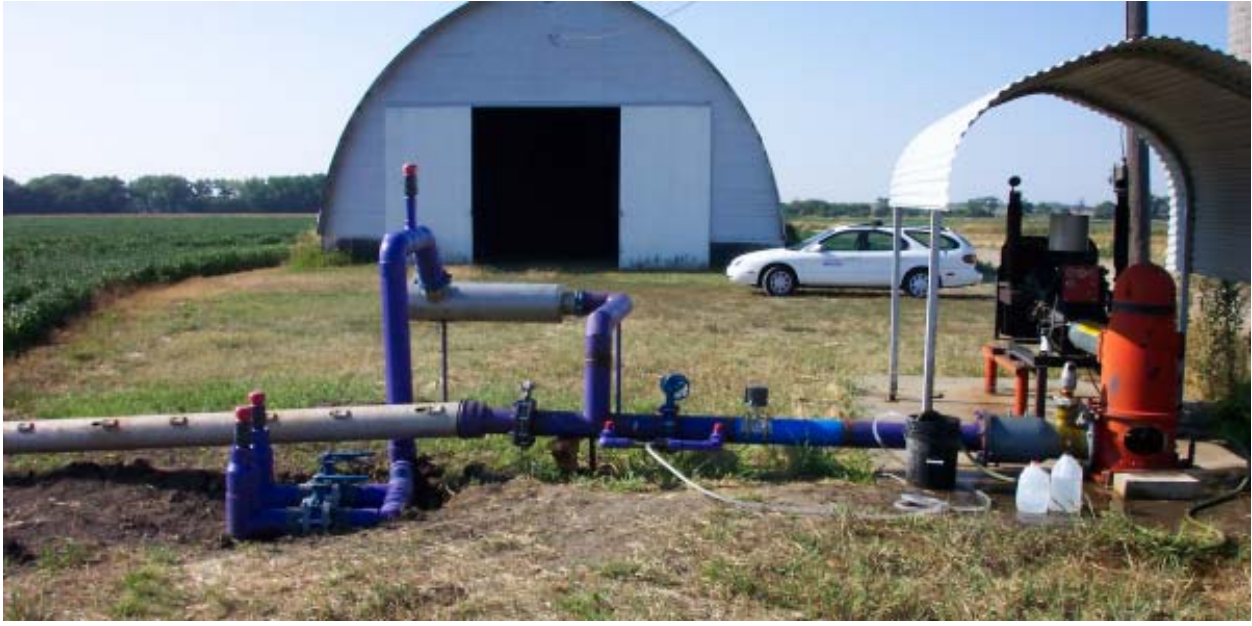
Figure 3b. Improved pumping plant and filtration configuration of the case study SDI system.
